**Flood Control Project Maintenance
Levee Inspections**

Maintenance Issue Types Only, Levee Inspection Report By Mile - Spring 2017

Tehama County Flood Control and Water Conservation District

Waterway	Bank	Unit Miles	Inspection Start/End	Inspector
Unit No. 01 Deer Creek	Left	4.22	04/25/2017 04/25/2017	Bob Duffey

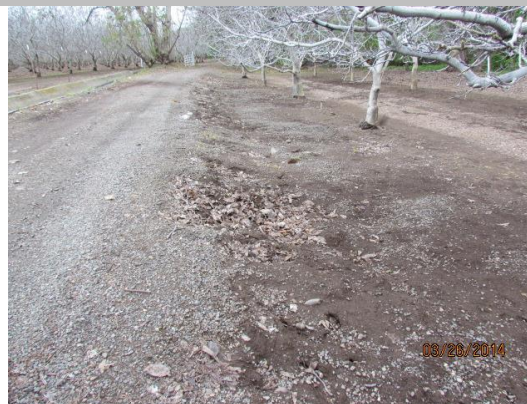
Photo 1 of 1 : SP_2017_NA0019_78_276_20170315_00016.jpg

LM Start	0.45	Rating **	M	Issue No.	276
LM End	0.45	Issue Type +	Ma	Location *	WS
Category	Earthen Levee			GPS Latitude/Longitude	
				Start	End
Item	Slope Stability			39.972377 °	39.972377 °
				-121.988559 °	-121.988559 °
DWR ID	DWR_NA0019_01_s_2014_276				
Comment Code					
S1 : Repair slope instability.					
Inspector Comment

View of the erosion along the waterside slope.

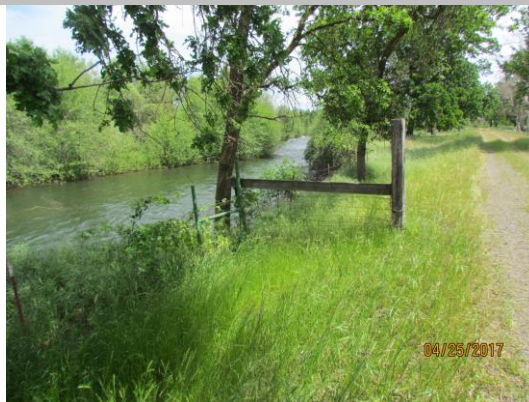
Photo 1 of 1 : SP_2017_NA0019_78_42_20170505_00059.jpg

LM Start	1.55	Rating **	U	Issue No.	42
LM End	1.58	Issue Type +	Ma	Location *	WS
Category	Earthen Levee			GPS Latitude/Longitude	
				Start	End
Item	Erosion / Bank Caving			39.969193 °	39.969052 °
				-122.008458 °	-122.008920 °
DWR ID	DWR_NA0019_01_s_2017_42				
Comment Code					
E2 : Schedule repair of erosion site prior to the next inspection.					
Inspector Comment					
Repair the erosion along the water side toe.

View of the erosion along the waterside toe.

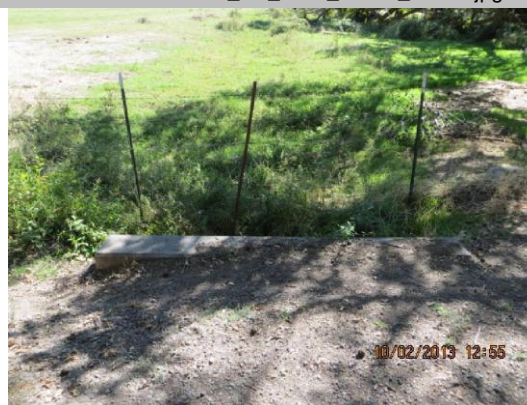
Photo 2 of 3 : UCIP_SP_2017_51437_36921.jpg

FS_ID:51437
DS_ID:20770
EP_NO: N/A
Repair Type: Non-Urgent
Crossing Status: Found
UCIP Comments: 12/05/2016 Sediment buildup inside pipe (see photo) and sediment buildup on WS blocking flap gate. Crossing has been downgraded from Urgent to Non-Urgent crossing was closed on both WS and LS. (O. Magana - DWR UCIP)10/02/2013 Flapgate blocked by soil buildup. (W. Wylie - DWR UCIP)
FIELD_STRUCT_DESC: 24-inch steel drainage pipe through the levee, 1.5 feet below the crown. Flap gate on the waterside (WS) toe.
[Additional Reference(s): DWR Levee Log, 1992. USACE Sacramento O&M Manual Unit 509, March 1957, As-built drawings available 50-4-2394 (Station 185+40)].
FS Date: 12/5/2016

Concrete headwall on LS toe.

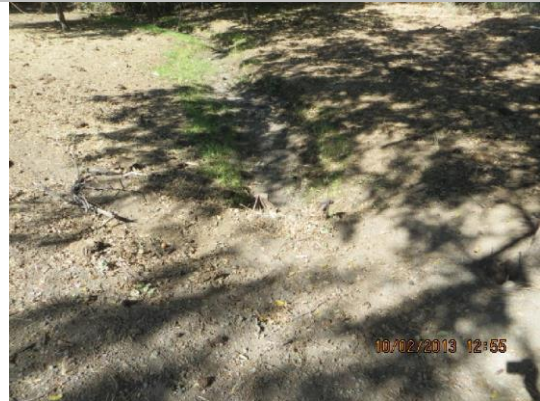
Photo 3 of 3 : UCIP_SP_2017_51437_36920.jpg

Item	DWR UCIP LMA Responsibility			39.968642 °	39.968642 °	
				-122.010494 °	-122.010494 °	
DWR ID						
Comment Code						
Inspector Comment						
FS_ID:51437 DS_ID:20770 EP_NO: N/A Repair Type: Non-Urgent Crossing Status: Found UCIP Comments: 12/05/2016 Sediment buildup inside pipe (see photo) and sediment buildup on WS blocking flap gate. Crossing has been downgraded from Urgent to Non-Urgent crossing was closed on both WS and LS. (O. Magana - DWR UCIP)10/02/2013 Flapgate blocked by soil buildup. (W. Wylie - DWR UCIP) FIELD_STRUCT_DESC: 24-inch steel drainage pipe through the levee, 1.5 feet below the crown. Flap gate on the waterside (WS) toe. [Additional Reference(s): DWR Levee Log, 1992. USACE Sacramento O&M Manual Unit 509, March 1957, As-built drawings available 50-4-2394 (Station 185+40)]. FS Date: 12/5/2016

Outlet on WS toe.

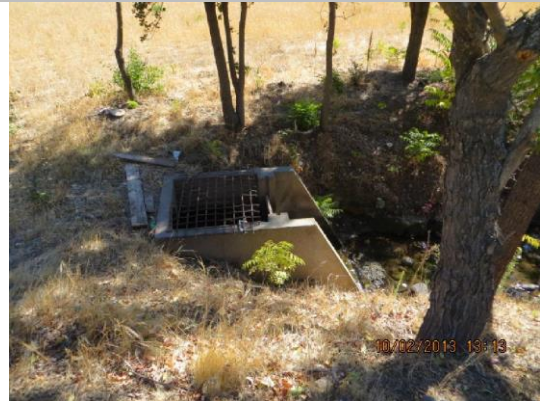
Photo 3 of 3 : UCIP_SP_2017_51438_36923.jpg

Item	DWR UCIP LMA Responsibility			39.969105 °	39.969105 °	
				-122.014028 °	-122.014028 °	
DWR ID						
Comment Code						
Inspector Comment						
FS_ID:51438 DS_ID:20769 EP_NO: N/A Repair Type: Urgent Crossing Status: Found UCIP Comments: 12/05/2016 same as last inspection. Crossing remains "Urgent" WS opened during flood season due to damaged flap gate. (O. Magana - DWR UCIP)10/02/2013 Flapgate missing or burried on WS toe. Pipe partially blocked by soil on WS toe. (W. Wylie - DWR UCIP) FIELD_STRUCT_DESC: 24-inch corrugated metal drainage pipe through the levee, 7 feet below the crown. Flap gate located on the waterside (WS) end. A 5-foot by 5-foot concrete control structure located on the landside (LS) toe. [Additional Reference(s): DWR Levee Log, 1992. USACE Sacramento O&M Manual Unit 509, March 1957, As-built drawing no. 50-4-2394 (Station 176+10)]. FS Date: 12/5/2016

Concrete control structure on LS toe.

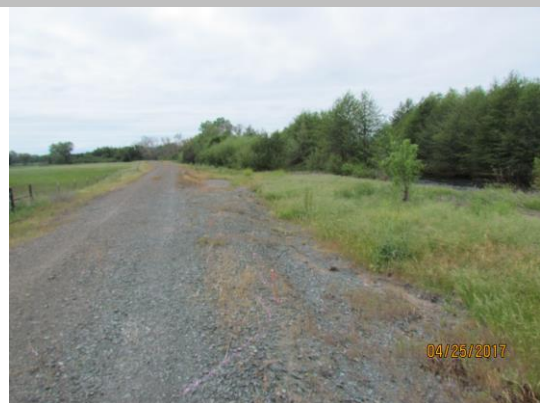
Photo 1 of 1 : SP_2017_NA0019_78_39_20170505_00063.jpg

LM Start	2.53	Rating **	M	Issue No.	39
LM End	2.53	Issue Type +	Ma	Location *	WS
Category	Earthen Levee			GPS Latitude/Longitude	
				Start	End
Item	Erosion / Bank Caving			39.966675 °	39.966675 °
				-122.024988 °	-122.024988 °
DWR ID	DWR_NA0019_01_s_2017_39				
Comment Code					
E2 : Schedule repair of erosion site prior to the next inspection.					
Inspector Comment					
Repair the erosion along the water side slope.

View of erosion along the waterside slope.

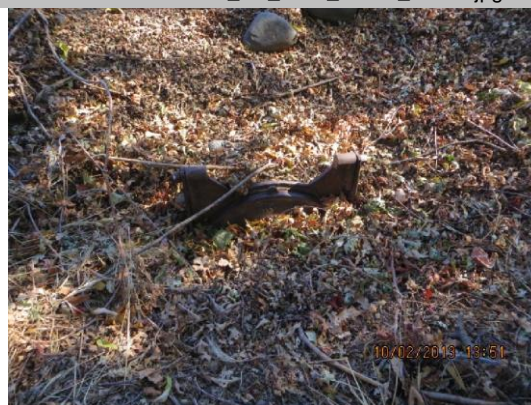
Photo 2 of 2 : UCIP_SP_2017_22824_38945.jpg

FS_ID:22824
DS_ID:20767
EP_NO: N/A
Repair Type: Non-Urgent
Crossing Status: Found
UCIP Comments: Pipe blocked by soil.
FIELD_STRUCT_DESC: 24-inch pipe through the levee 6-feet below the crown. Flap gate on the waterward end. Originally included in O+M manual (1957). As-built drawings available 50-4-2394.
FS Date: 10/2/2013

Flapgate blocked by soil and debris.

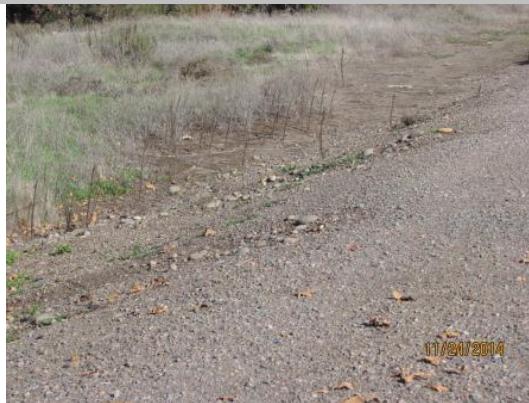
Photo 1 of 1 : SP_2017_NA0019_78_38_20170315_00012.jpg

LM Start	2.86	Rating **	M	Issue No.	38
LM End	2.86	Issue Type +	Ma	Location *	LS
Category	Earthen Levee			GPS Latitude/Longitude	
				Start	End
Item	Slope Stability			39.963928 °	39.963928 °
				-122.030120 °	-122.030120 °
DWR ID	DWR_NA0019_01_f_2014_38				
Comment Code					
S1 : Repair slope instability.					
Inspector Comment

View of erosion from the cattle on both slopes.

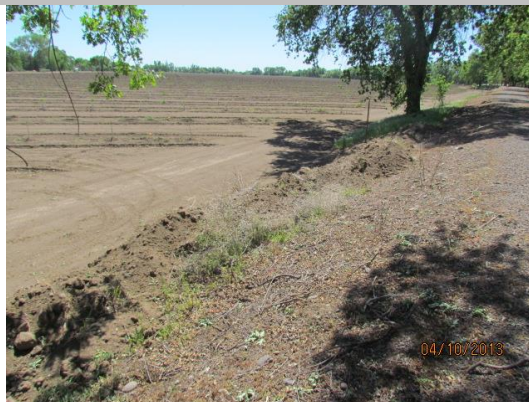
Photo 1 of 1 : SP_2017_NA0019_78_20_20170315_00007.jpg

LM Start	2.88	Rating **	M	Issue No.	20
LM End	2.88	Issue Type +	Ma	Location *	LS
Category	Earthen Levee			GPS Latitude/Longitude	
				Start	End
Item	Slope Stability			39.963709 °	39.963709 °
				-122.030384 °	-122.030384 °
DWR ID	DWR_NA0019_01_s_2013_20				
Comment Code					
S1 : Repair slope instability.					
Inspector Comment

View of the erosion along the landside slope.

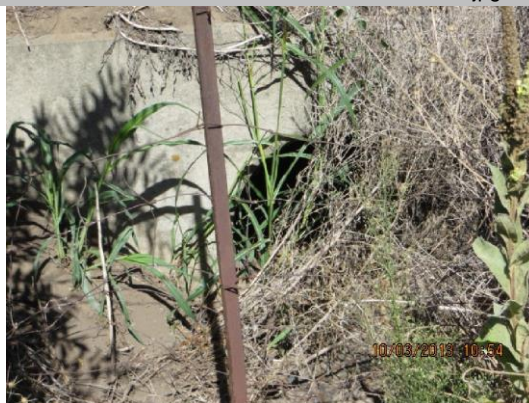
Photo 1 of 3 : UCIP_SP_2017_21741_36937.jpg

LM Start	4.03	Rating **	A/W	Issue No.	291
LM End	4.03	Issue Type +	Ma	Location *	WS
Category	Supplemental			GPS Latitude/Longitude	
				Start	End
Item	DWR UCIP LMA Responsibility			39.941574 °	39.941574 °
				-122.057597 °	-122.057597 °
DWR ID					
Comment Code					
Inspector Comment					
FS_ID:21741					
DS_ID:20760					
EP_NO: N/A					
Repair Type: No Action Needed					
Crossing Status: Found					
UCIP Comments:					
FIELD_STRUCT_DESC: 24-inch corrugated metal stormdrain pipe through the levee, 5-feet below the crown. Flap gate on the waterward end. Headwalls on both sides of levee. Originally included in O+M manual (1957). As-built drawing No. 50-4-2394.					
FS Date: 10/3/2013

Pipe and concrete headwall on LS toe.

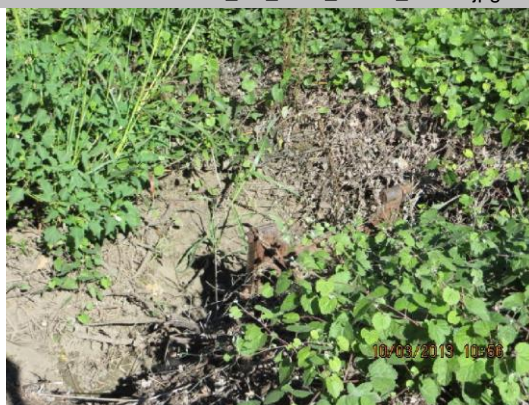
Photo 2 of 3 : UCIP_SP_2017_21741_36936.jpg

Flapgate on WS toe.

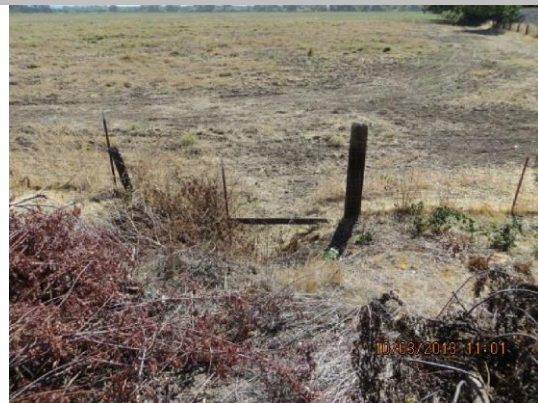
Photo 1 of 3 : UCIP_SP_2017_51441_36942.jpg

LM Start	4.10	Rating **	U	Issue No.	292
LM End	4.10	Issue Type +	Ma	Location *	WS
Category	Supplemental			GPS Latitude/Longitude	
				Start	End
Item	DWR UCIP LMA Responsibility			39.941002 °	39.941002 °
				-122.058711 °	-122.058711 °
DWR ID					
Comment Code					
Inspector Comment					
FS_ID:51441 DS_ID:20762 EP_NO: N/A Repair Type: Urgent Crossing Status: Found UCIP Comments: 12/05/2016 unable to complete inspection -- unable to locate. (O. Magana - DWR UCIP)10/03/2013 Gate missing from WS toe. (W. Wylie - DWR UCIP) FIELD_STRUCT_DESC: 24-inch corrugated metal drainage pipe through the levee, 5.5 feet below the crown. Flap gate located on the waterside (WS) end. Concrete headwall located on the landside (LS) toe. [Additional Reference(s): DWR Levee Log, 1992. USACE Sacramento O&M Manual Unit 509, March 1957, As-built drawing no. 50-4-2394 (Station 0+65)]. FS Date: 12/5/2016

Inlet on LS toe.

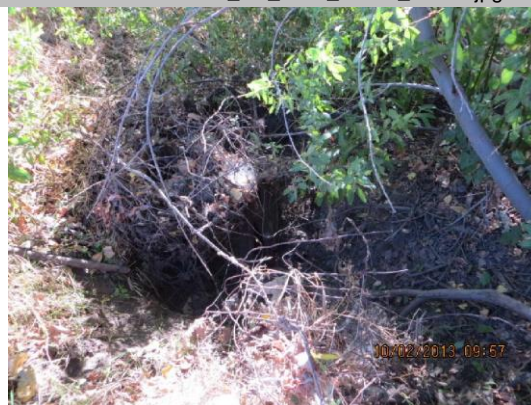
Photo 3 of 3 : UCIP_SP_2017_51442_36900.jpg

FS_ID:51442
DS_ID:20771
EP_NO: N/A
Repair Type: Non-Urgent
Crossing Status: Found
UCIP Comments: 12/05/2016 Crossing has been downgraded from Urgent to Non-Urgent some debris blocking proper function of flapgate on WS. Recommend clearing debris from WS for flapgate to function properly. (O. Magana - DWR UCIP)10/01/2013 Debris blocking proper function of flapgate on WS toe. (W. Wylie - DWR UCIP)
FIELD_STRUCT_DESC: 24-inch steel drainage pipe through the levee, 8.3 feet below the crown. Flap gate located on the waterside (WS) end. Concrete headwall located on the landside (LS). [Additional Reference(s): DWR Levee Log, 1992. USACE Sacramento O&M Manual Unit 509, March 1957, Unit 510, April 1963, Unit 511, May 1973, Unit 512, March 1964, Unit 513, December 1970, As-builts drawing 50-4-2394 (Station 155+40)].
FS Date: 12/5/2016

Outlet on WS toe.

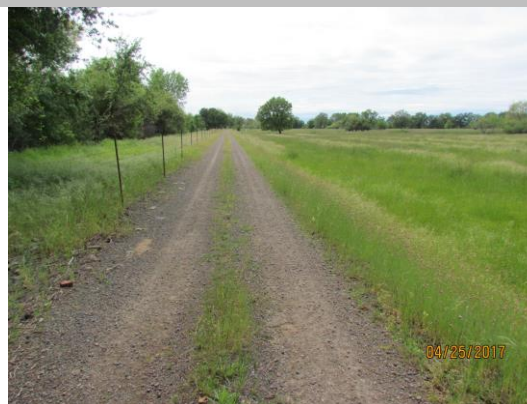
Photo 1 of 1 : SP_2017_NA0019_79_18_20170505_00017.jpg

View of native grasses on both slopes.

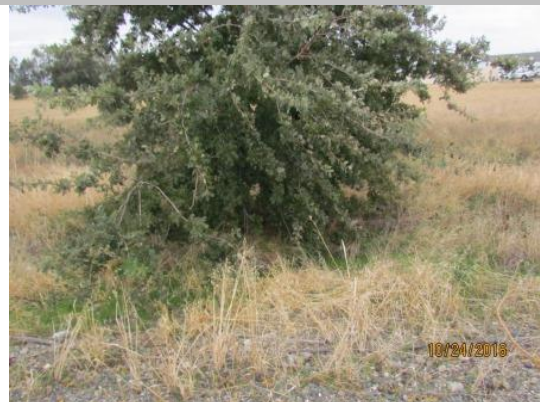
Photo 1 of 1 : SP_2017_NA0019_81_13_20170315_00008.jpg

View of a tree with overhanging branches.

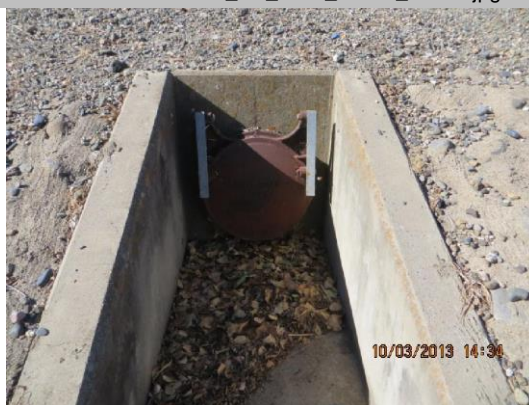
Photo 3 of 3 : UCIP_SP_2017_22827_38972.jpg

Flapgate on headwall at WS toe.

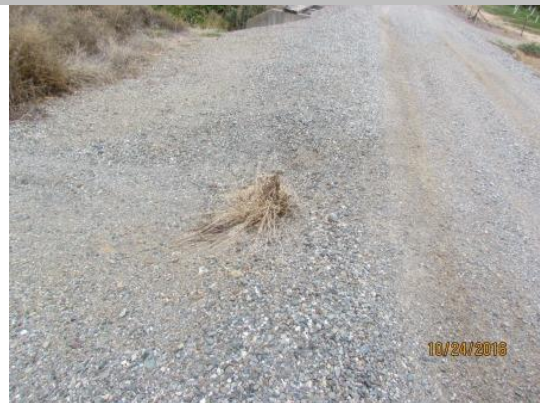
Photo 1 of 2 : SP_2017_NA0019_81_3_20170315_00004.jpg

View of a dip along the levee slope.

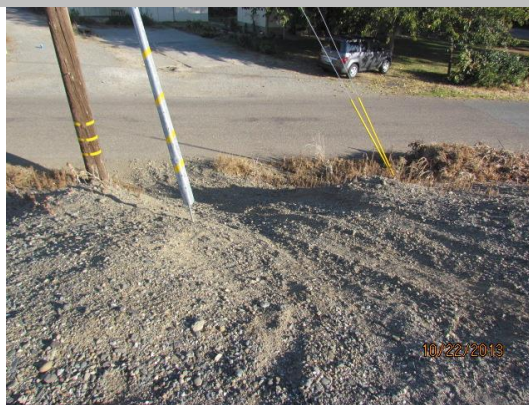
Photo 1 of 1 : SP_2017_NA0019_81_12_20170315_00007.jpg

View of the slope instability caused by vehicles along the landside slope.

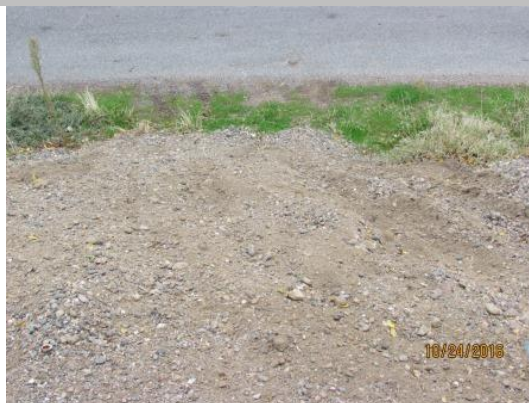
Photo 1 of 1 : SP_2017_NA0019_81_30_20170315_00019.jpg

View of the slope instability caused by vehicles along the landside slope.

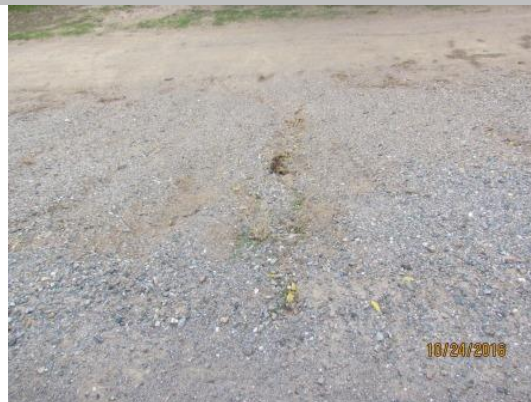
Photo 1 of 1 : SP_2017_NA0019_81_916_20170315_00025.jpg

View of the slope instability caused by vehicles along the landside slope.

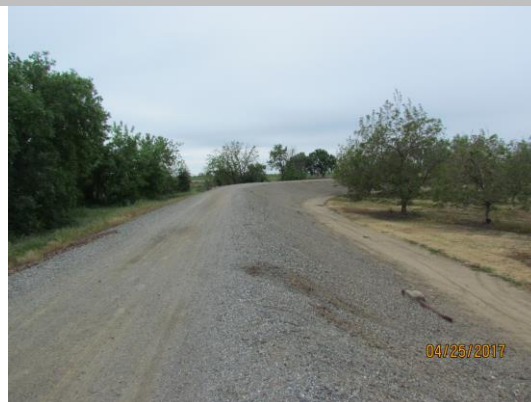
Photo 1 of 1 : SP_2017_NA0019_81_52_20170505_00080.jpg

View of no vegetation on both slopes.
